# BH Home Inspections

Confidential - Property Inspection Report - Confidential

123 Main Street, York PA, 17403  
Inspection prepared for: John Smith  
Inspection Date: 1/4/2010 Time: 9:30 AM  
Age: 56 years Size: 1288 sft  
Weather: sunny, 40 degrees  
Move-In Certified Seller Inspection

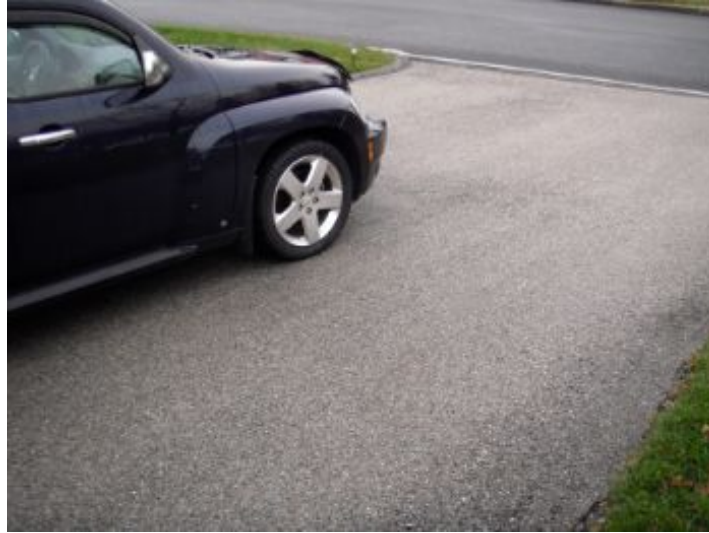
Driveway in very good condition.

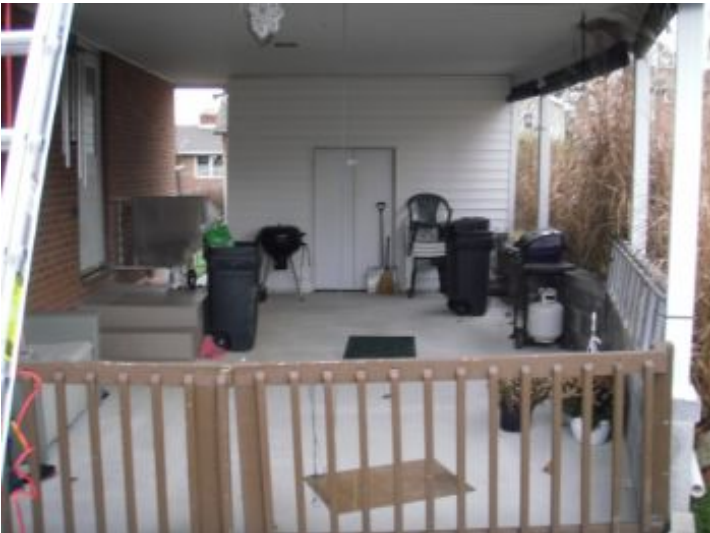
- Carport floor, wall and storage room was upgraded and in very good condition. No deficiencies noted.

All components of carport in very good condition with recent upgrades.

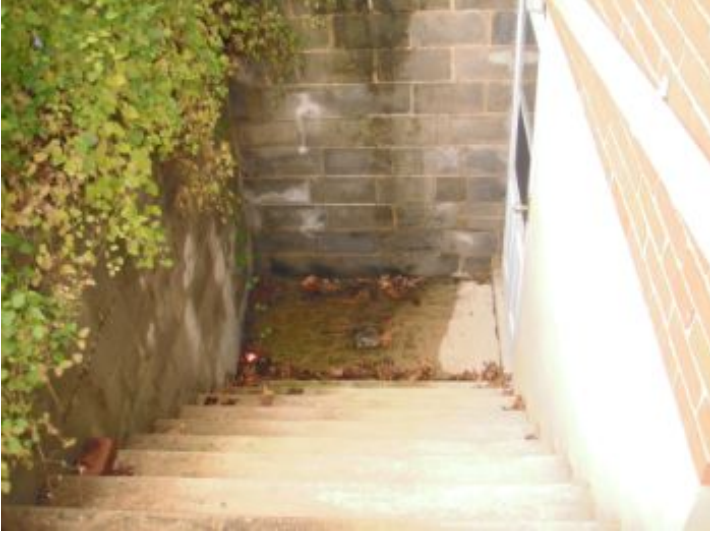
- There were no railings installed at the exterior steps leading into the basement. At the front and side entrance steps, there is a railing along the top of the landings, but not the steps. Recommend installation of railings where steps are present as a concern for safety.

Recommend installation of a railing on steps into basement.

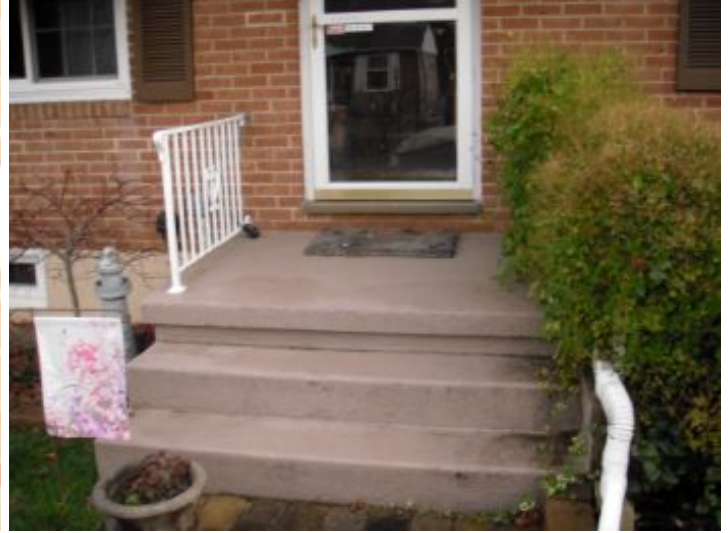
Recommend railing on front entrance steps.

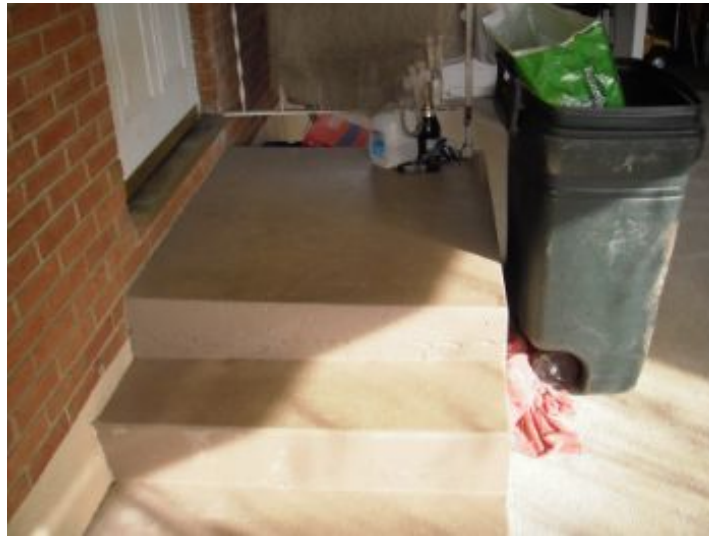
Recommend installing railing at side entrance steps.

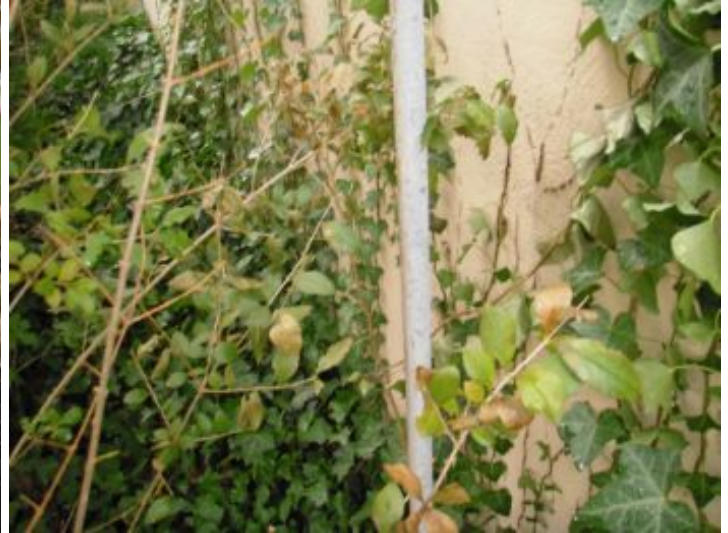
- Vegetation too close to the building can cause harm through root damage to the foundation, branches abrading the roof and siding, and leaves providing a path for moisture and insects into the home.
- Recommend trimming trees back and removing Ivy from the structure to prevent moisture and insect intrusion.

Trees and Ivy up against structure. Recommend keeping vegetation away from structure.

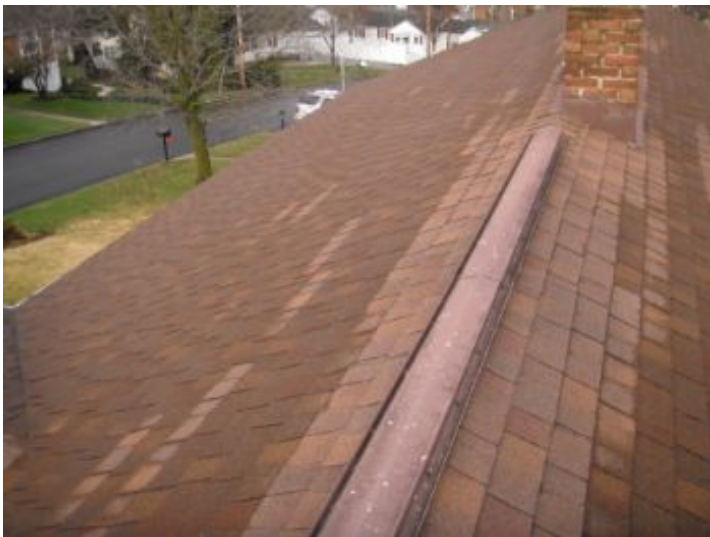
Roof covering appeared in good condition.

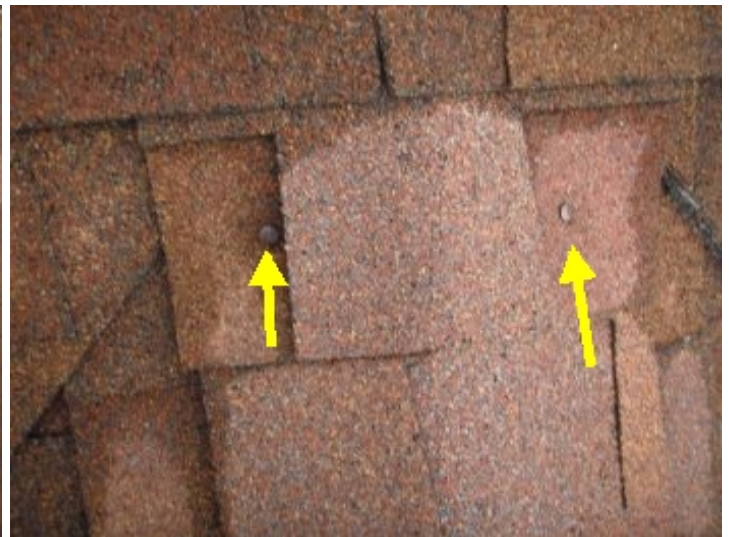
- These shingles appear to be in the first third of their life cycle, and generally in good condition. One noted concern is at peak over front porch there are exposed nail heads that should be sealed to prevent water intrusion.

Exposed nail heads should be sealed to prevent water intrusion.

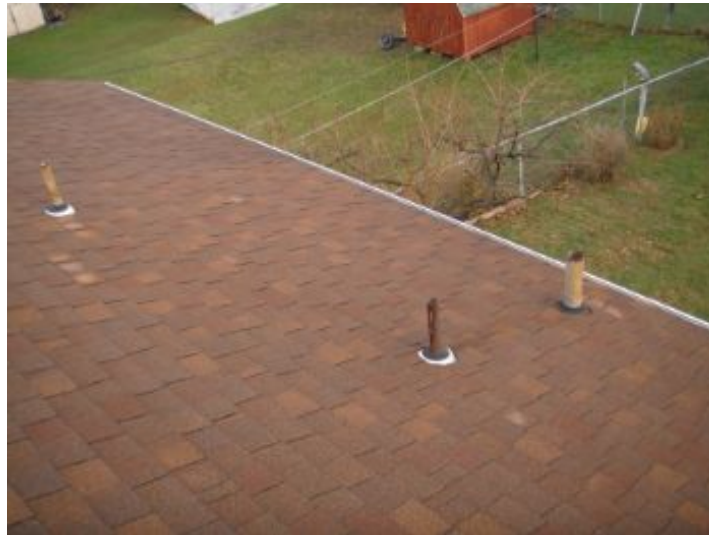
Penetrations/flashings appeared in good condition, at time of inspection.

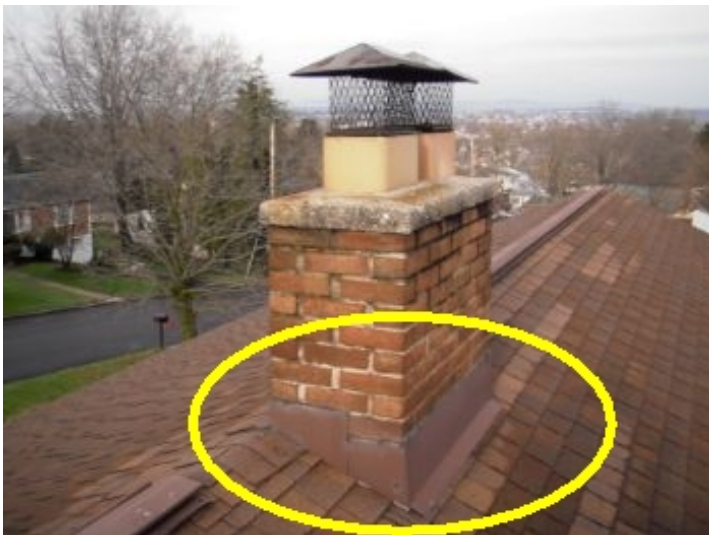
- Moisture on chimney in attic indicates moisture intrusion possible through flashing around chimney exterior. Recommend sealing around flashing by a qualified roofing contractor.

Moisture on chimney in attic indicates moisture intrusion possible through flashing around chimney exterior. Recommend sealing around flashing by a qualified roofing contractor.

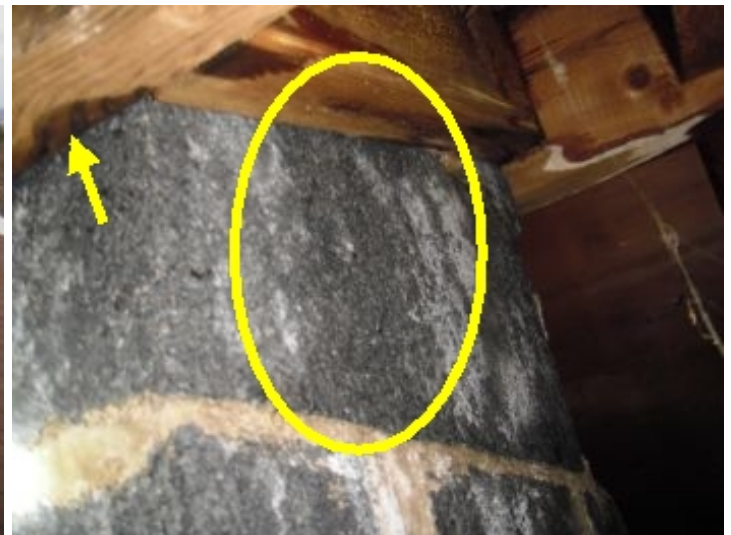
Moisture on chimney surface in attic.

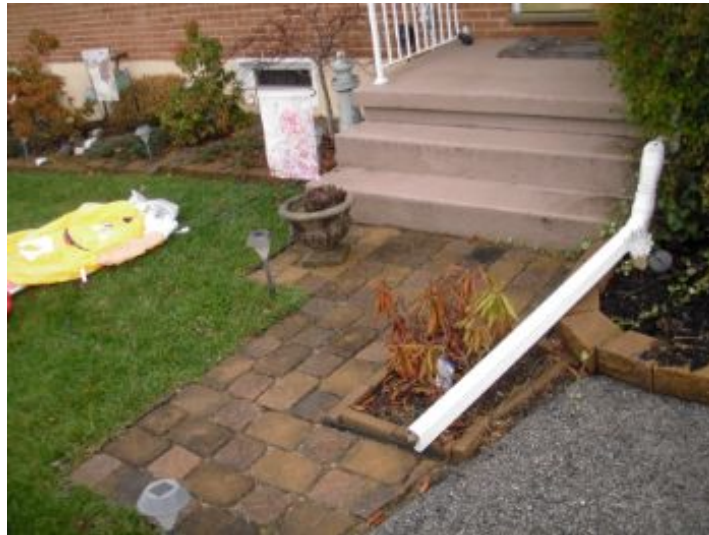
- The roof drainage system appeared in good and serviceable condition, at time of inspection.
- One noted deficiency with downspout discharge at front of home. The water is expelled onto the walkway and driveway, creating a slipping hazard in cold weather conditions. Recommend diverting water from walkways.

Downspout discharges onto walkway and driveway at front of home. This is a potential hazard in cold weather.

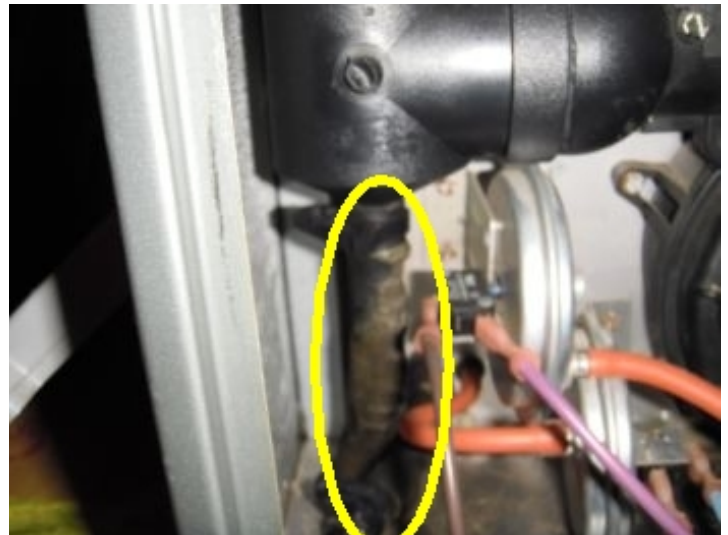
Condensate hose at trap is deteriorated and leaking down into the blower compartment.

Condensate hose on furnace is leaking and must be replaced.

Recommend hose replacement by a qualified HVAC contractor as soon as possible to avoid moisture intrusion onto electrical components.

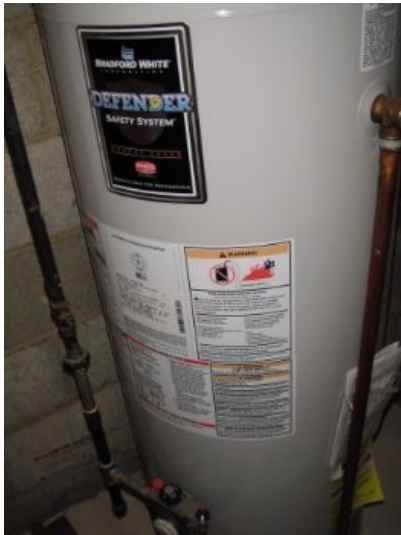
Age: 3 Years  
 Observations:  
 • Water Heater and expansion tank appear to be in very good condition -- no concerns.

40 Gal Bradford-White W/H. Very good condition.
