# BH Home Inspections

Confidential - Property Inspection Report - Confidential

123 Main Street, York PA, 17403  
Inspection prepared for: John Smith  
Inspection Date: 1/4/2010 Time: 9:30 AM  
Age: 56 years Size: 1288 sft  
Weather: sunny, 40 degrees  
Move-In Certified Seller Inspection

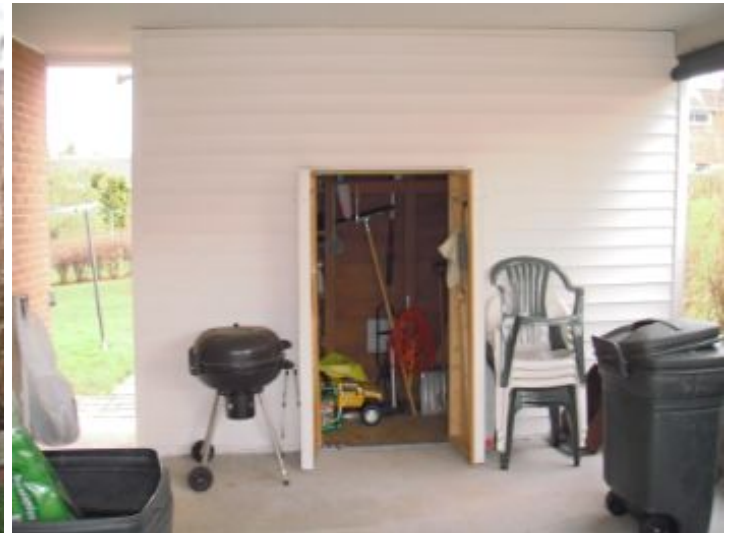
Carport storage room.

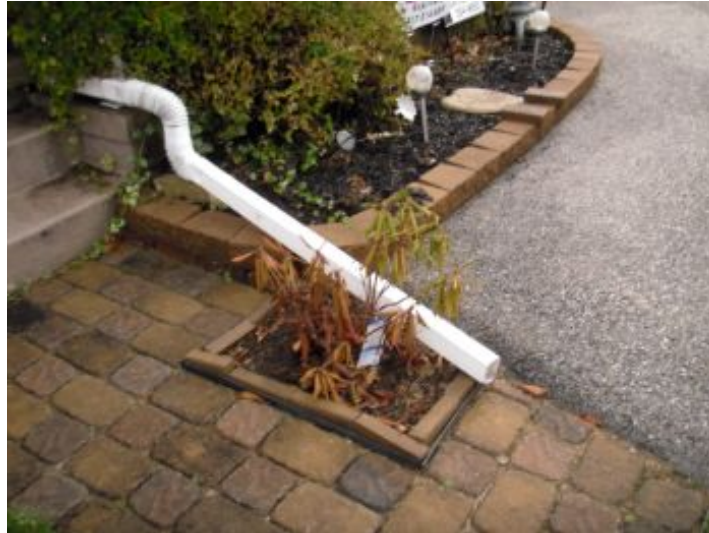
- At the time of the inspection the stone pavers appeared in good condition.

Nice stone pavers at front entrance.

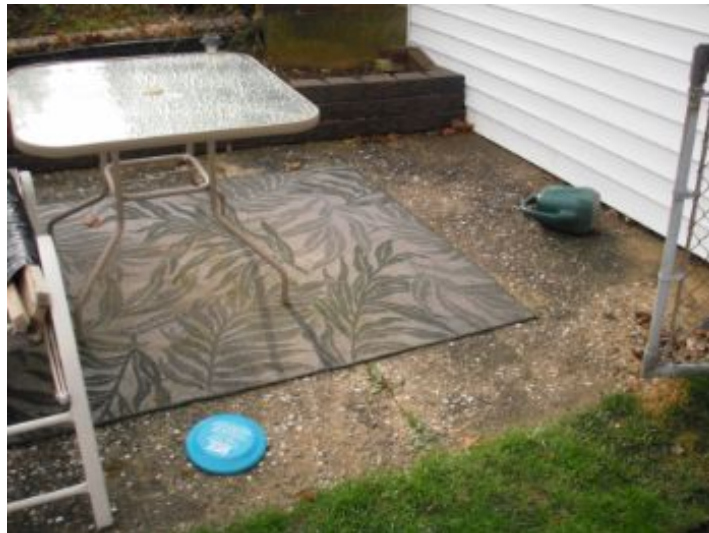
- Rear concrete patio appeared in good condition.

Rear concrete patio appeared in good condition.

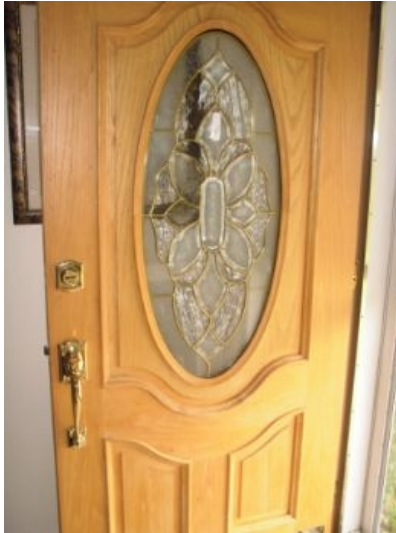
- Appeared in functional and in good condition, at time of inspection. Very nice front entrance door is a recent upgrade.

Nice front entrance door-recent upgrade.

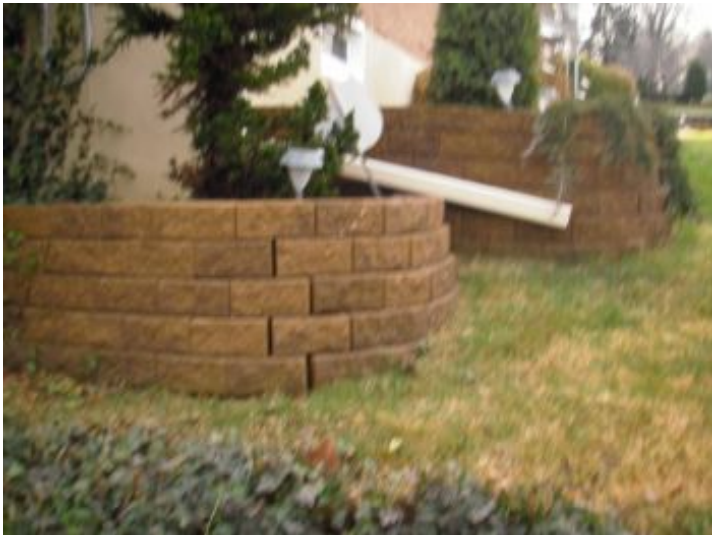
**Observations:** No deficiencies noted with the retaining wall in front of home or block wall along side of carport. Block wall was recently replaced.

Retaining walls in good condition.

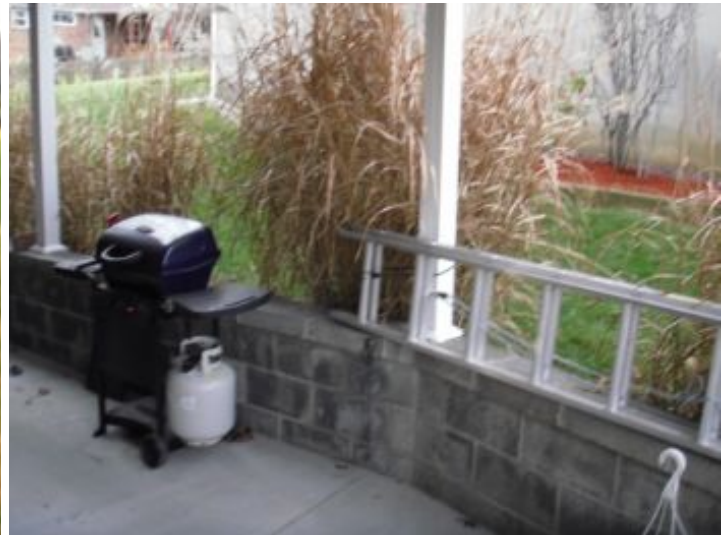
No deficiencies noted with the retaining wall in front of home or block wall along side of carport. Block wall was recently replaced.

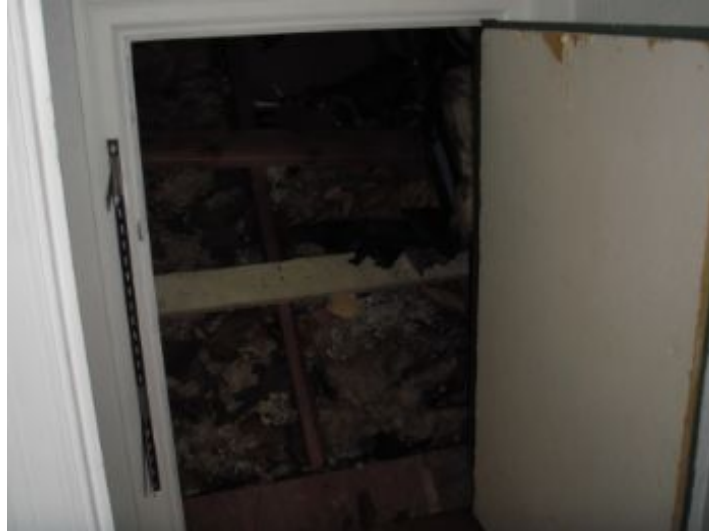
**Observations:** Not the easiest access, but no deficiencies and typical of homes of this age and style.

Attic access in Living Room closet.

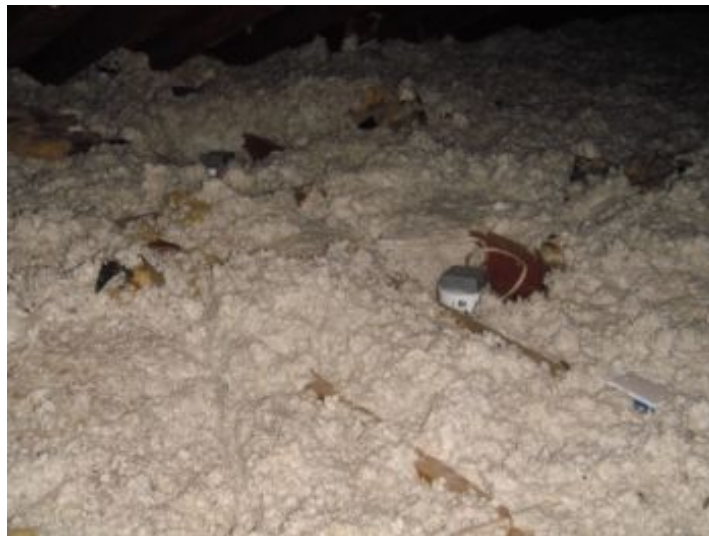
- Insulation appears adequate.

Insulation appears adequate.

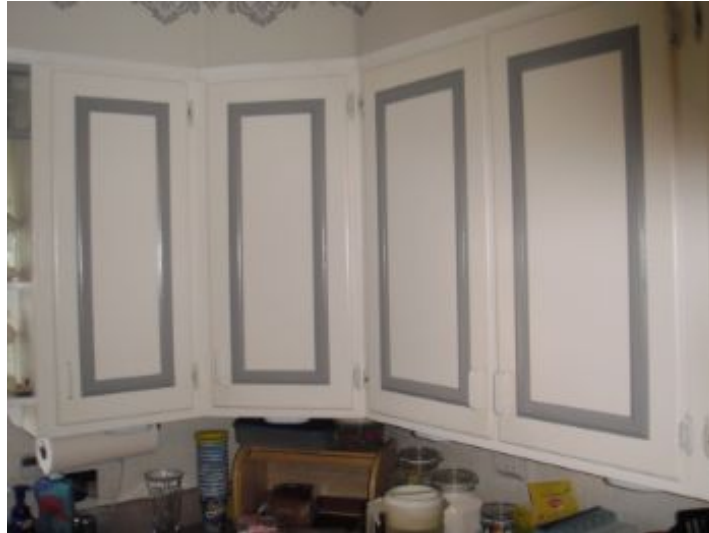
**Materials:** Wood  
**Observations:**  
 • No deficiencies observed on kitchen cabinets and bathroom vanities.

Well maintained Kitchen cabinets

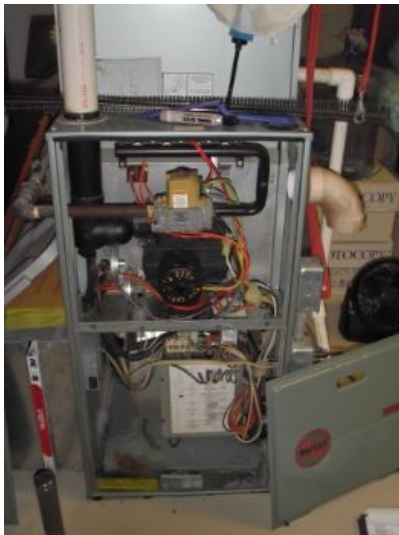
Ruud 90% FHA Furnace

Condensate hose at trap is deteriorated and leaking down into the blower compartment.

Recommend hose replacement by a qualified HVAC contractor as soon as possible to avoid moisture intrusion onto electrical components.

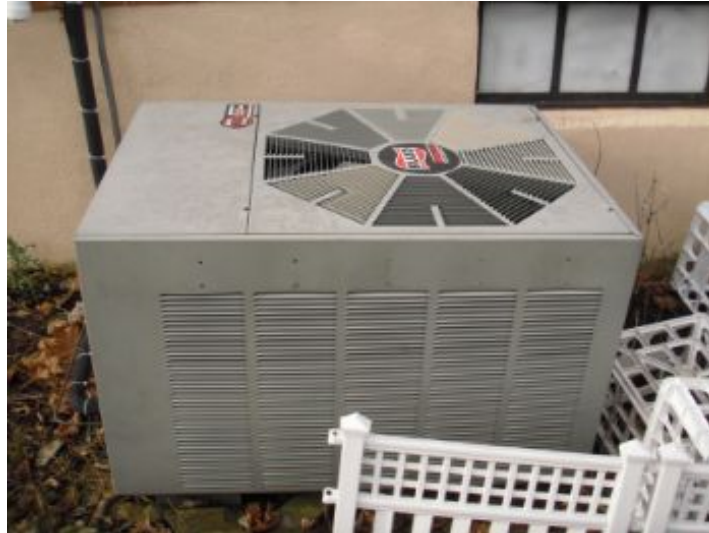
- The visible portions of the cooling system appeared in good condition and well maintained, although due to low outdoor temperatures, the A/C operation could not be checked. Recommend service by a qualified HVAC contractor when temperatures exceed 65 degrees.

Ruud 2 ton A/C condensing unit.

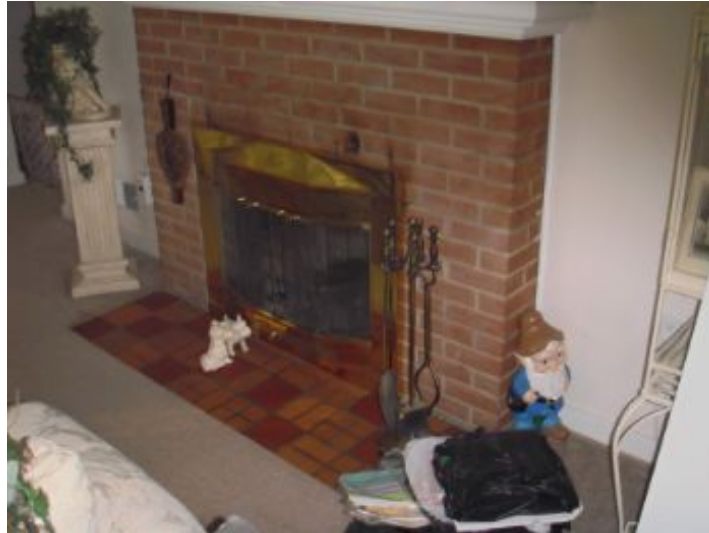
- The damper operated properly when tested.

Wood burning fireplace in Living Room.

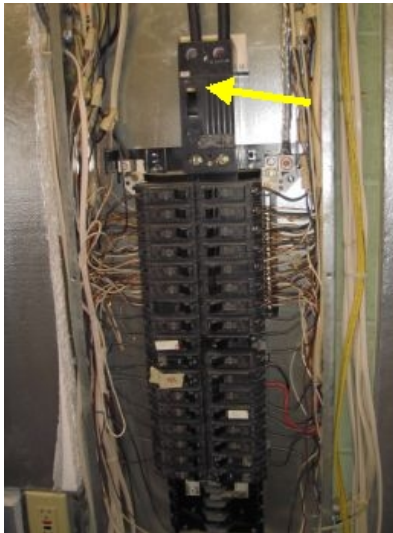
Main Service Panel/Main Disconnect

- The wiring within the panel appeared satisfactory and functional.

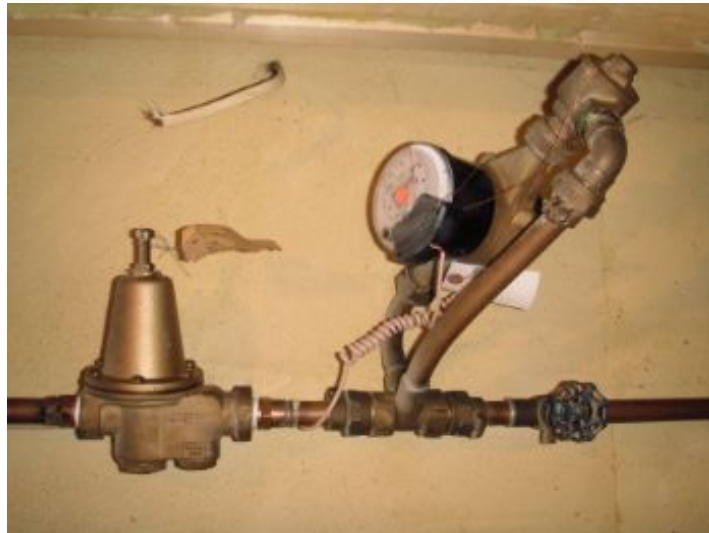
Observations:  
 • No deficiencies noted.

Main Water Shutoff w/ pressure reducing valve -located behind shelf in basement.

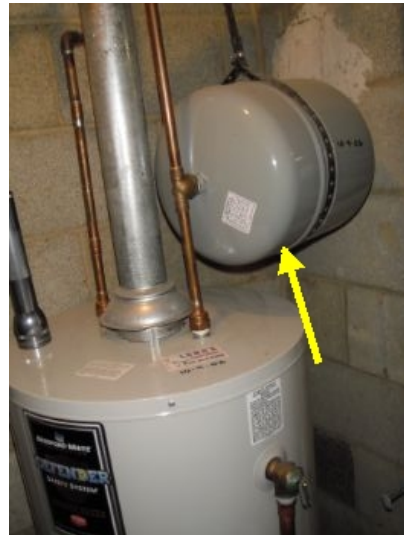
Expansion tank to protect W/H.
